## **Agilent Technologies Firmware Upgrade Kit 08665-61114 for the 8665A Synthesized Signal Generator**

**Part Number 08665-90067  
Printed in USA November 2004  
Supersedes March 2004**

## Firmware Upgrade Kit 08665-61114 for the 8665A Synthesized Signal Generator

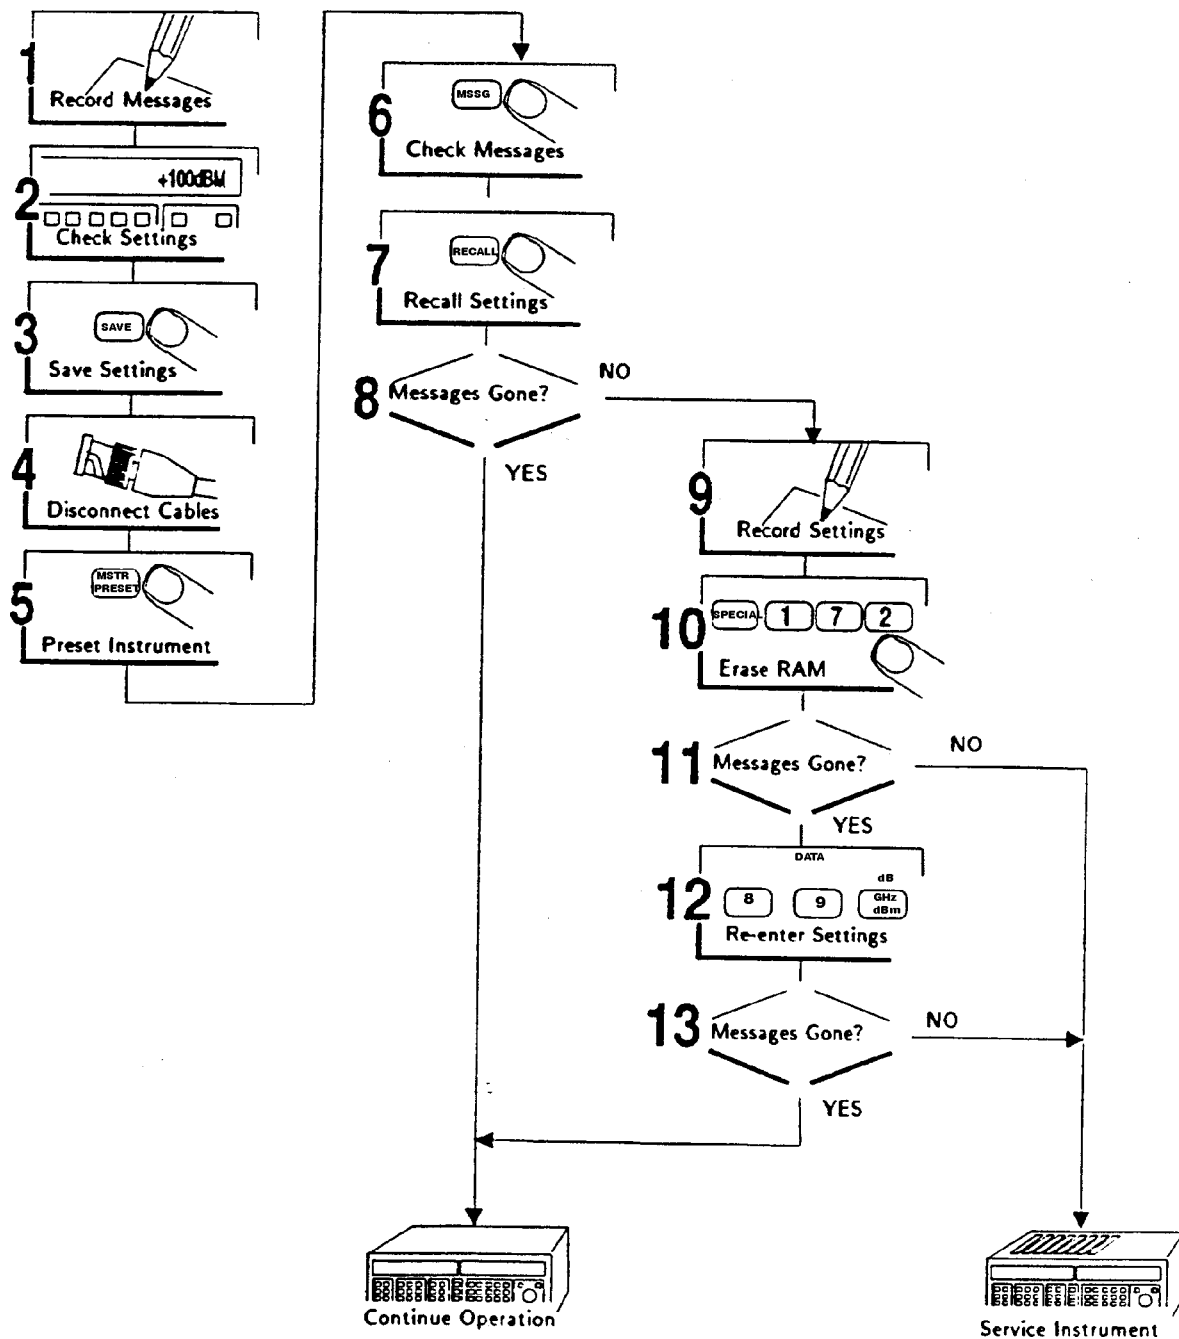
Figure 1. Corrective Action for Error Messages

| <b>Error Message</b> | <b>Description</b> |
|---|---|
| Hardware Failure 1 | A communications discriminator failure has been detected at power up, or detected as a result of a self-calibration or self-test. Refer to Figure 1 for corrective action. |
| Hardware Failure 2 | A VCO failure has been detected at power up, or detected as a result of a self-calibration or self-test. Refer to Figure 1 for corrective action. |
| Hardware Failure 5 | An ALC failure has been detected at power up, or detected as a result of a self-calibration or self-test. Refer to Figure 1 for corrective action. |

| <b>Error Message</b> | <b>Description</b> |
|---|---|
| Hardware Failure 31 | A ROM failure has been detected at power up, or detected as a result of a self-calibration or self-test. Refer to Figure 1 for corrective action. |

| <b>Error Message</b> | <b>Description</b> |
|---|---|
| Calibration Error 1 | A condition occurred where invalid level calibration data resides in either the Output or the Attenuator modules. Follow the external calibration procedures outlined in Figure 1. |
| Calibration Error 2 | At sometime during the calibration or self-test, a condition occurred where some hardware was unable to be calibrated. Fix the hardware and re-calibrate. Refer to Figure 1 for corrective action. This error message will always be accompanied by other error messages. |
| User Memory Cleared | A memory failure has been detected, all battery backup memory is lost. Refer to Figure 1 for corrective action. |
